Inspection Report

Ground Up Inspection Services LLC

PROPERTY INSPECTION REPORT

6/30/2017

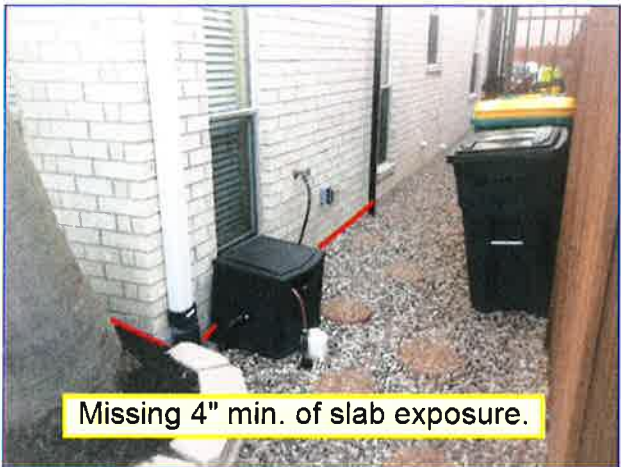
1. Lacking a minimum of 4" foundation exposure on front side under windows and along the right side of home. Recommend repair by a professional landscaper. (photos 1-2)
2. Tree roots can potentially cause damage to foundations. It recommended that all trees be removed or replanted at least 10ft away from the foundation.

A. Item 1(Picture) Missing 4" of slab exposure right side.

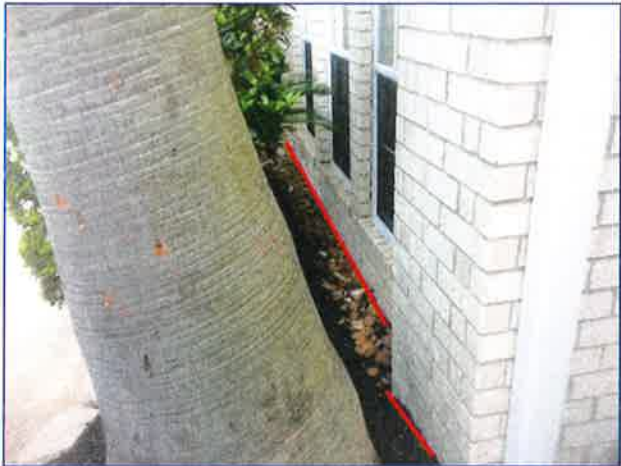
A. Item 2(Picture) Missing 4" minimum slab exposure at front.

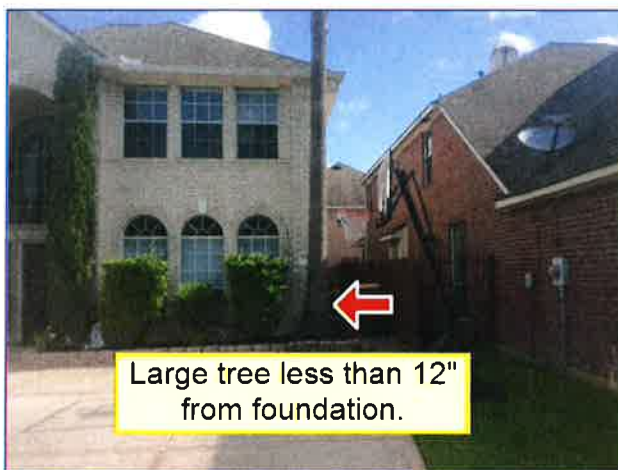
A. Item 4(Picture) Recommend trees be planted minimum 15ft away from the foundation.

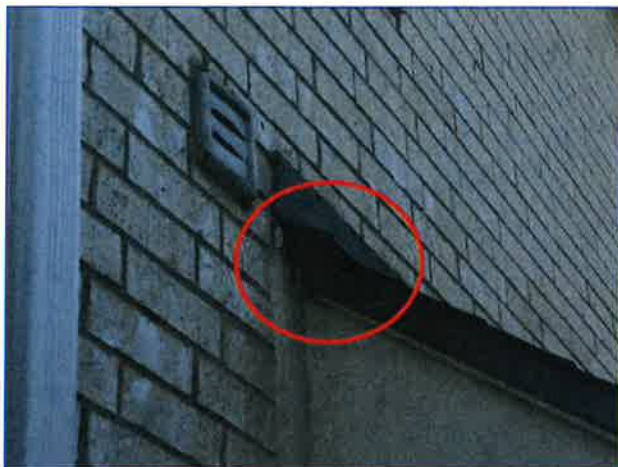
1. The flashing over the right side bay window is beginning to lift. This could potentially allow water to intrude under the flashing causing water damage to the roof decking. Recommend repair.

C. Item 1(Picture) Flashing above left side bay window at left corner is beginning to lift.

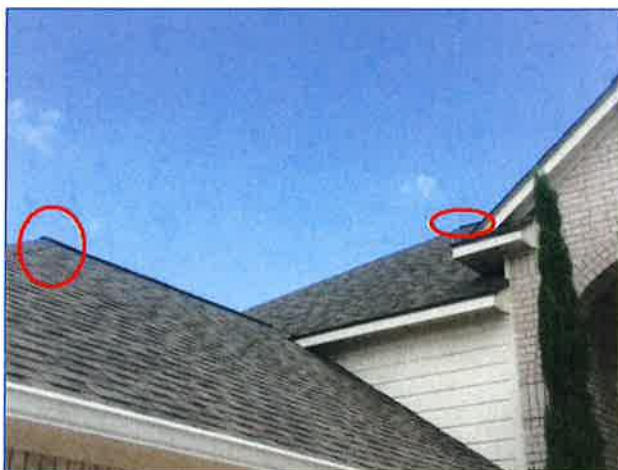
2. Ridge vents should terminate at least 6" from the edge of the run. When you run the vent all the way to the end it leaves room for an exposed opening. When you stop it short of the edge you can run a ridge cap

under the vent to prevent possible water damage. Although this most likely does not affect the venting process of the attic it is just noted as a incorrect installation of the ridge vent.

C. Item 3(Picture) All ridge vents to terminate 6 inches from the end of the run.

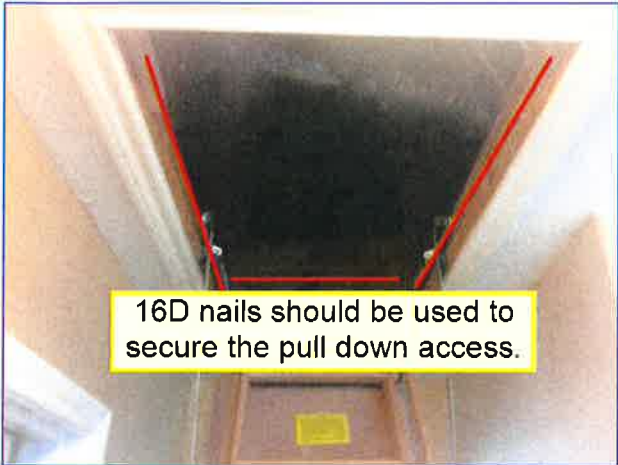
1. The attic access pull down was installed using screws in lieu of the proper 16D penny nails that are recommended. Using deck screws rather than the proper 16D nails may reduce the shear strength and may not support the ladder. Recommend installing proper 16D nails to support the ladder. Apply 2ea on the ends and 3ea on each side for proper installation.
2. The attic must have a clear unobstructed step off point from the access ladder and a clear catwalk to all mechanical unit. This step off and catwalk should be a minimum of 24' wide, clear and unobstructed.
3. The water heater does not have the required clear work platform in front of the unit. This work space should be a clear 30" space in front of the unit. Currently a technician must stand on the attic access to perform maintenance on the water heater which is unsafe.

16D nails should be used to secure the pull down access.

D. Item 1(Picture) Attic pull down stairs should be secured with 16D nails. Currently installed with screws.

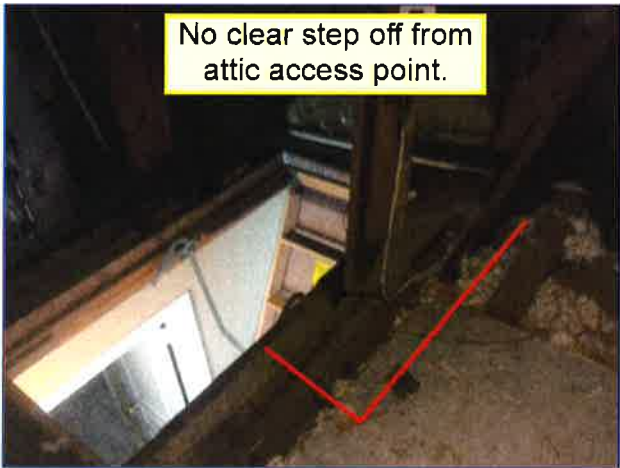
No clear step off from attic access point.

D. Item 2(Picture) No clear step off from attic access to mechanicals.

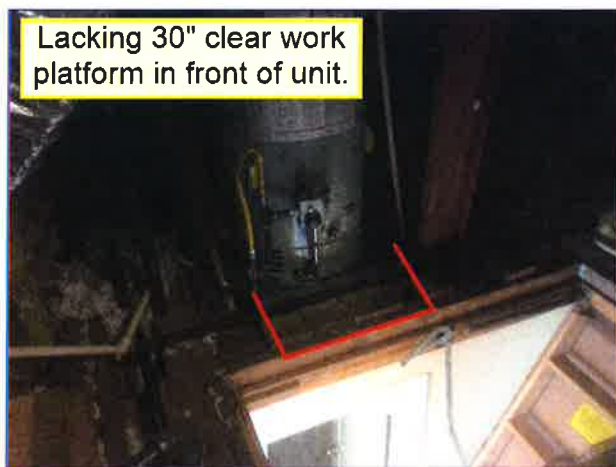
D. Item 3(Picture) Missing 30" clear work space in front of water heater in attic.

No.	IMC	IRC	Description
1	306.3	1305.1.3	Minimum 30" x 30" level work area
2	306.3	1305.1.3	- Install mechanical appliances in available areas for observation, maintenance and replacement
3	306.2	1305.1.3	Minimum 24" solid floor path

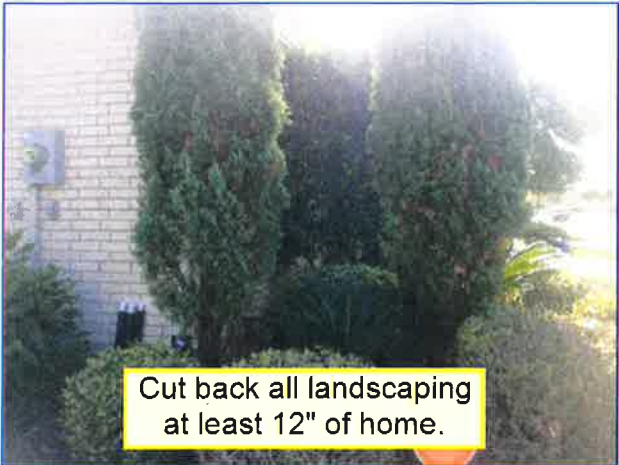
1. Across the front and left side of the home all vegetation should be cut back at least 12" off the exterior cladding of the home so that air may circulate around the structure to assist in drying of moisture.
2. Missing weep hole at bottom row of brick at the rear patio column. Recommend installing weep holes.
3. The siding on the rake walls should not be in direct contact with the shingles. It is recommend that the siding be a minimum of 1.5" off the roof covering to prevent water wicking and premature deterioration of the siding material.
4. Recommend cleaning all mildew off the homes siding to help maintain and prevent premature deterioration of the material.

Cut back all landscaping
at least 12" of home.

E. Item 1(Picture) Cut all landscape back 12" from structure.

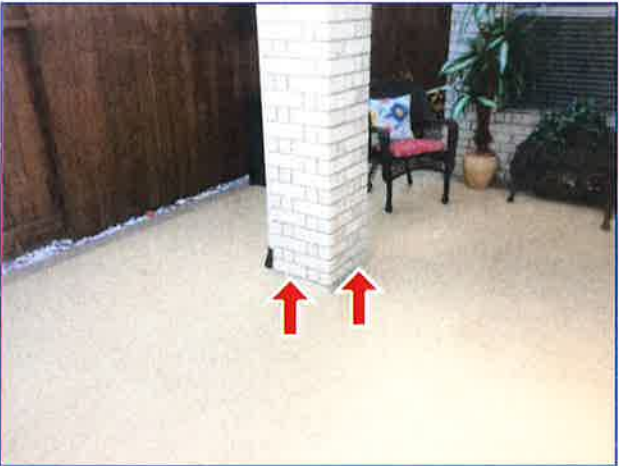
E. Item 2(Picture) Rear patio columns missing weep holes.

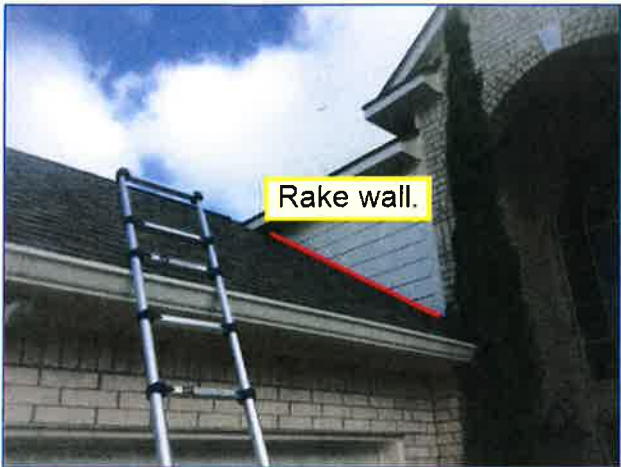
E. Item 4(Picture) Siding on rake walls should be minimum 1.5" off the roof covering (shingles)

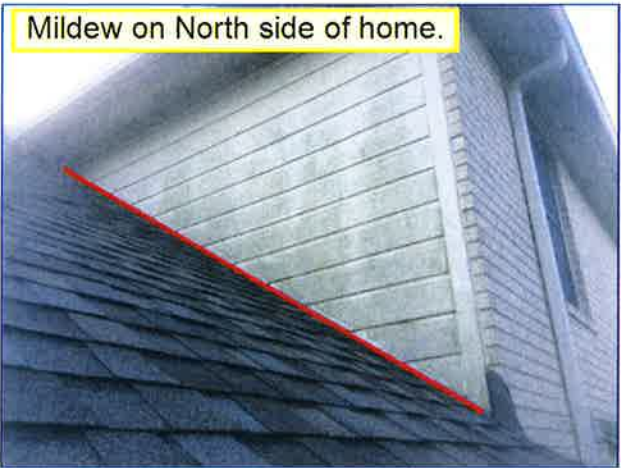
E. Item 5(Picture) Mildew on rear siding facing north should be cleaned.

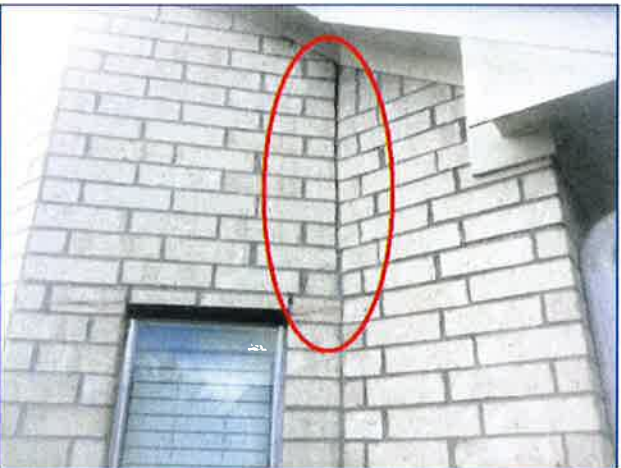
5. Observed settlement crack in brick at the rear left corner of the home. This crack travels through a mortar joint of the brick and is considered to be common with the natural movement of the home. Recommend touching up with brick mortar at this time.

E. Item 6(Picture) Movement crack observed at left rear corner of home.

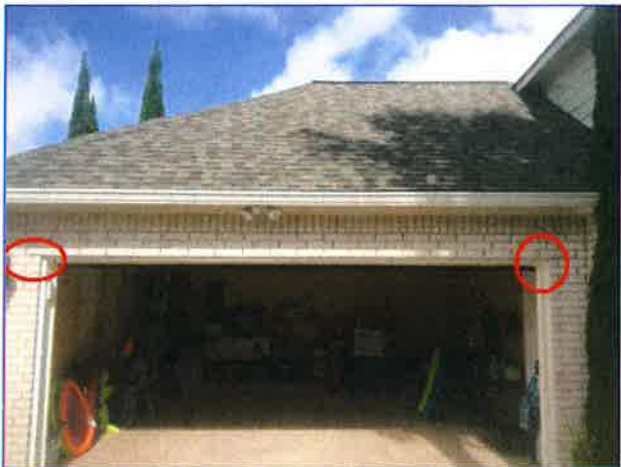
6. Brick lintel is rusting at the ends of the steel lintel above the garage door. When steel lentils rust they tend to expand and may cause some diagonal cracking in the brick. Recommend painting as maintenance to prevent further rusting.

E. Item 7(Picture) Paint rusted ends of brick lentil on left and right side of garage door.

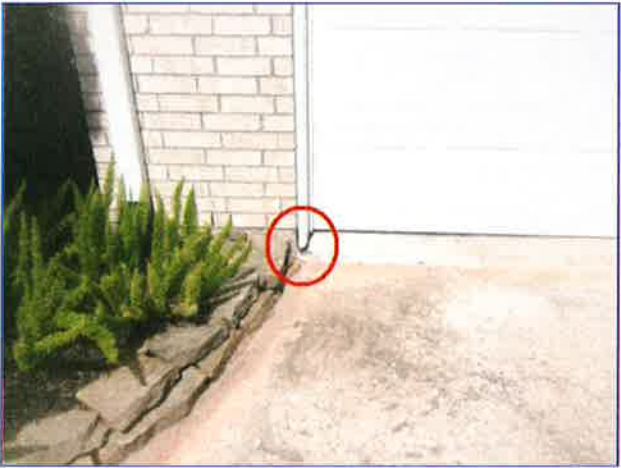
7. Large gap at bottom of garage door trimmers between it and the concrete. This gap may allow water to intrude behind the trimmer and cause deterioration and rotting. the bottom edge of the trimmer is showing the beginning signs of premature deterioration. Recommend caulking and sealing the trimmer to the concrete to prevent future water damage to the door trimmer.

E. Item 8(Picture) Bottom of the garage door trimmers to concrete.

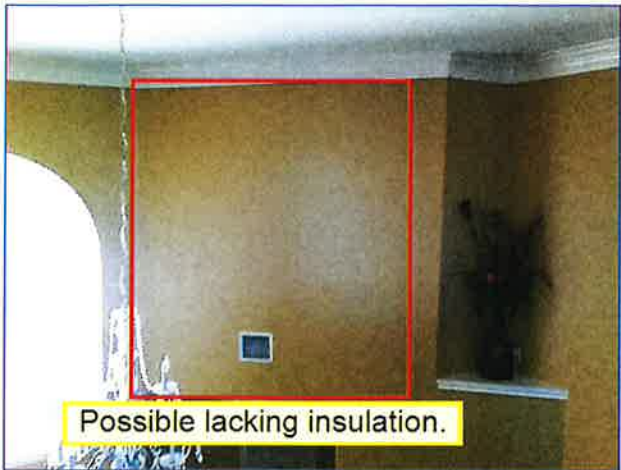
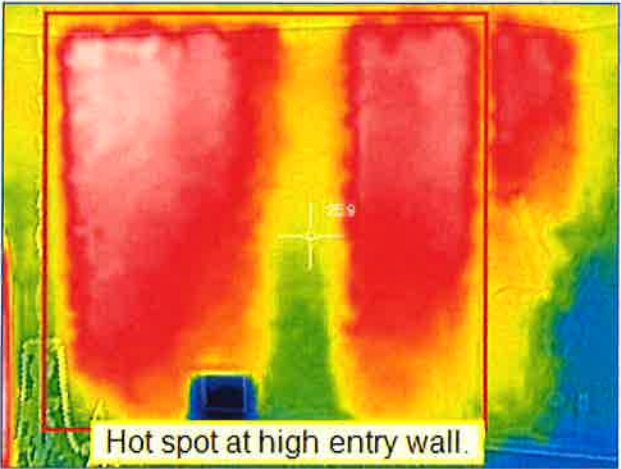
8. Warm spot indicated through thermal imaging camera in entry wall above the utility room door. Possibly missing insulation in wall cavity. Although the temperature difference was not easily felt while in the room, further assessment is recommended.

E. Item 9(Picture) Hot spot indicated at high entry wall.

E. Item 10(Picture) Hot spot indicated at high entry wall.

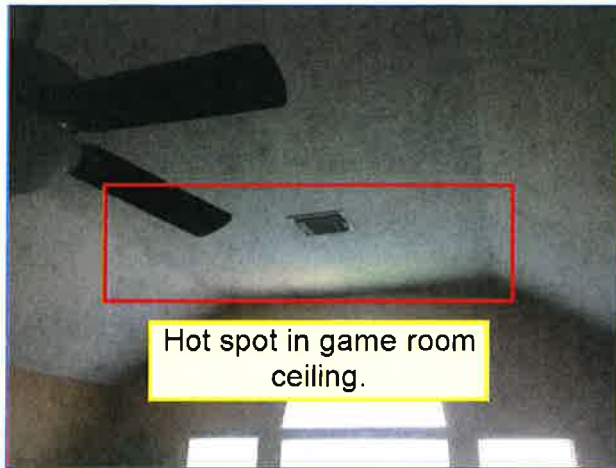
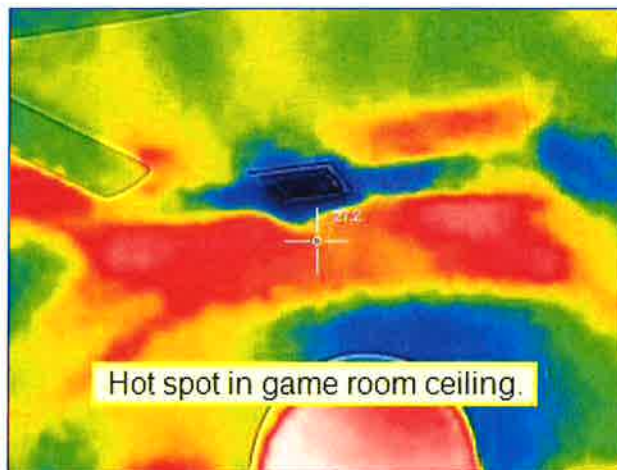
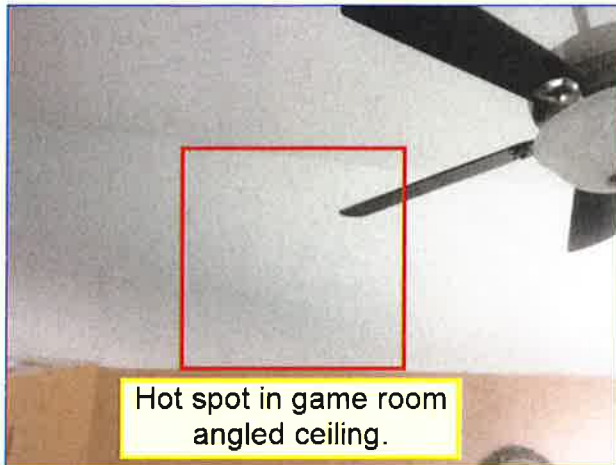
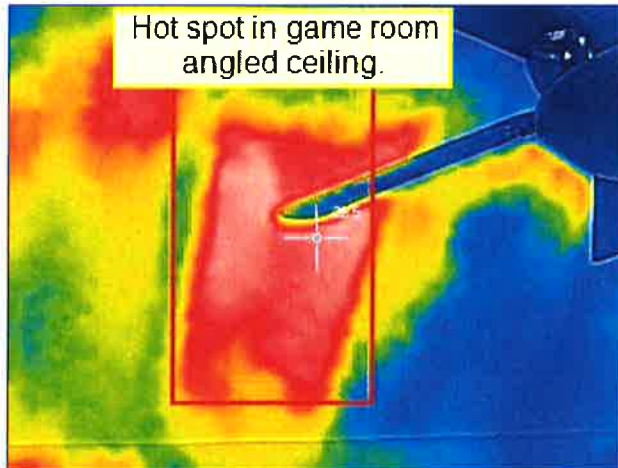
1. A hot spot in the game room ceiling near the rear wall was indicated through thermal imaging. Possible missing insulation in this area in the attic. Further assessment is recommended.
2. On the left side of the game room in the angled ceiling a hot spot was indicated. possible missing insulation in this area of the attic. Further assessment is recommended.
- 3.

F. Item 1(Picture) Hot spot in game room ceiling.

F. Item 2(Picture) Hot spot indicated in game room ceiling.

F. Item 3(Picture) Hot spot in game room angled ceiling.

F. Item 4(Picture) Hot spot in left side game room angled ceiling.

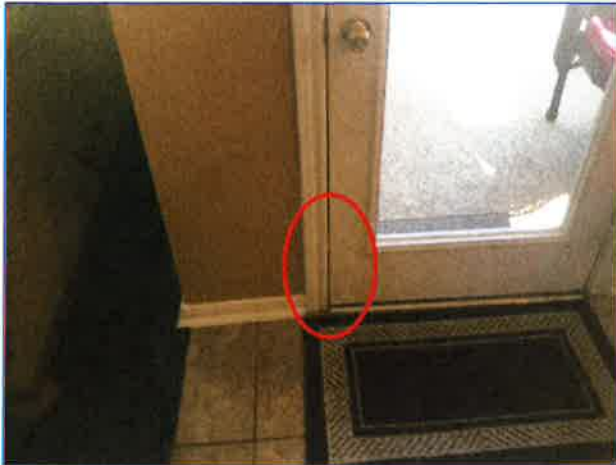
G. Item 1(Picture) Small amount of daylight penetrating through rear door.

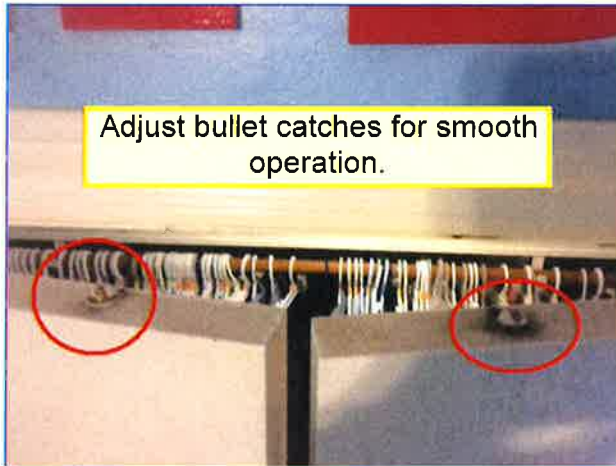
G. Item 2(Picture) Adjust bullet catches on closet doors for smooth operation front left bedroom closet

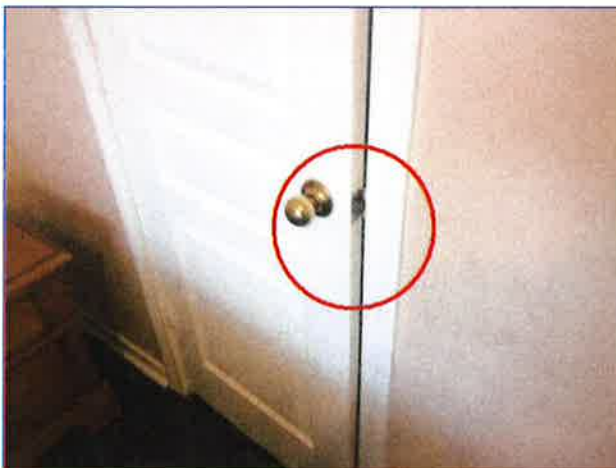
G. Item 3(Picture) Door latch mechanism does not function at upper right rear bedroom closet.

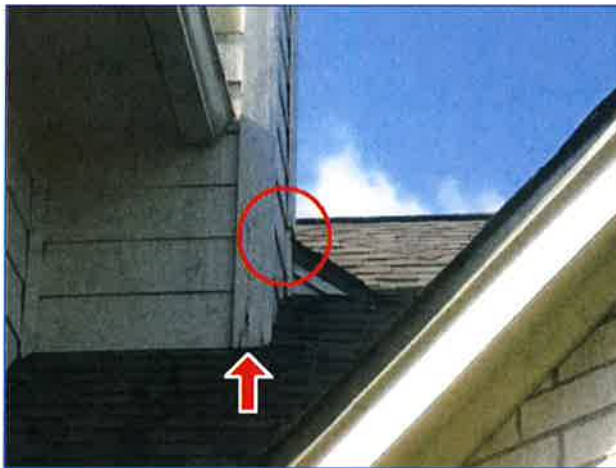
1. Observed signs of rotting on the chimney 1x4 trim. Recommend repair.

J. Item 1(Picture) Fireplace 1x4 show signs of rotting and deterioration.

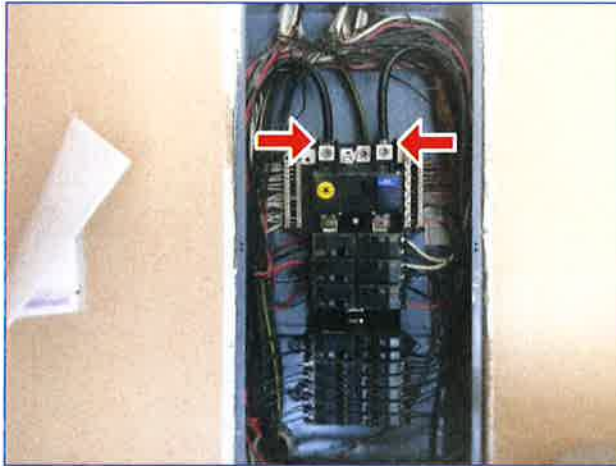
1. Missing anti oxidant gel on the main aluminum conductors at the main lugs. Aluminum conductors have a tendency to heat up more than copper and this may cause corrosion at the main lugs. Although it is not required by code it is recommended due to the characteristics of aluminum wiring.

A. Item 1(Picture) Missing anti oxidant gel on main aluminum conductors main lug nuts.

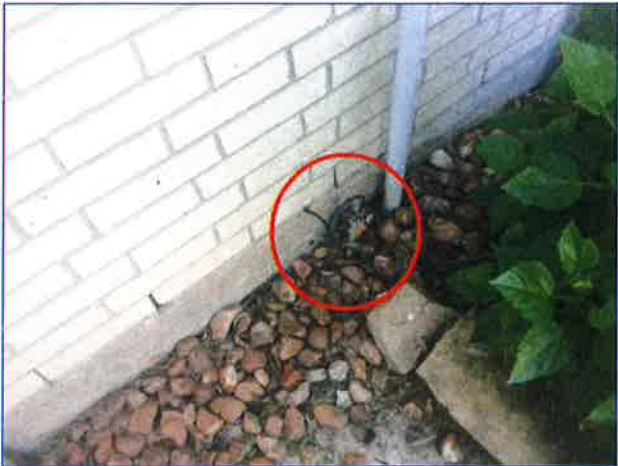
1. The grounding rod located on the left front side of the home should be flush with the grade. For proper operation repair is recommended.

B. Item 1(Picture) Grounding rod should be flush with grade.

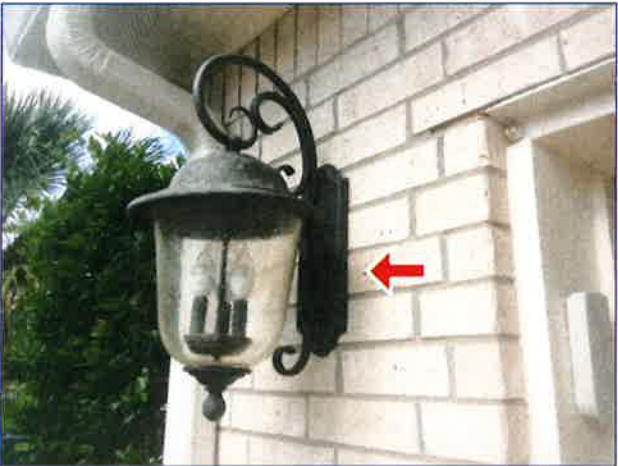
2. All exterior lights should be caulked and sealed to the brick. This will help prevent possible water intrusion behind and into the junction box.

B. Item 2(Picture) Caulk and seal all exterior coach lights to brick.

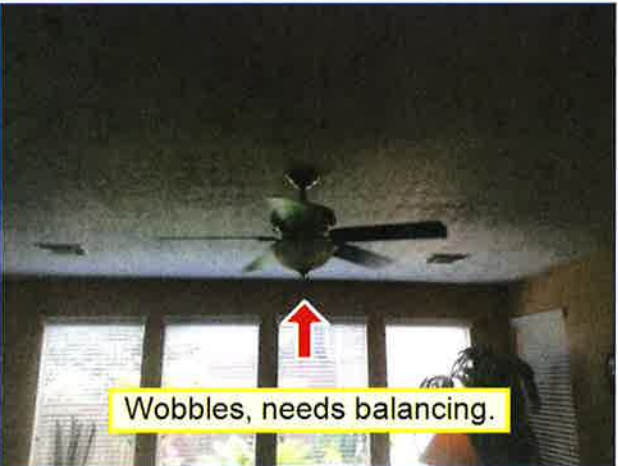
3. The living room ceiling fan wobbles on medium speed. Recommend fan be balanced for proper operation.

B. Item 3(Picture) Living room ceiling fan wobbles on medium speed need balancing.

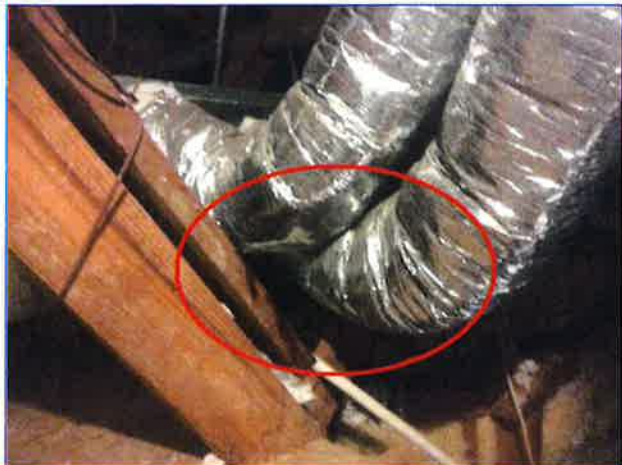
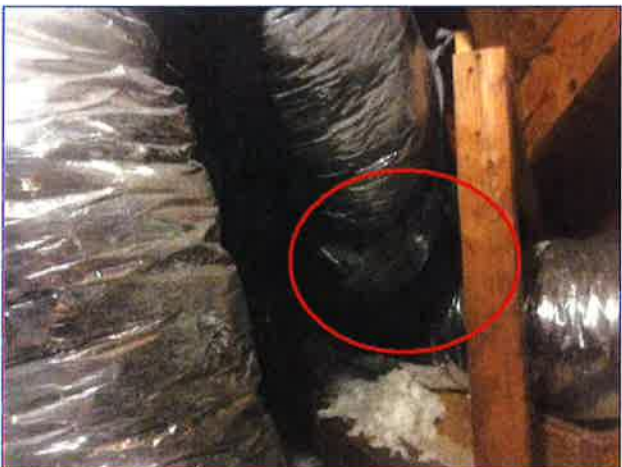
1. Observed multiple air ducts in the attic that are in contact with one another. This may cause condensation and in turn cause possible water damage to the ceiling below it. Recommend separating all ducts with batt insulation for a repair.

C. Item 1(Picture) Ducts in contact of one another.

C. Item 2(Picture) Ducts in contact with one another.

C. Item 3(Picture) Ducts in contact with one another.

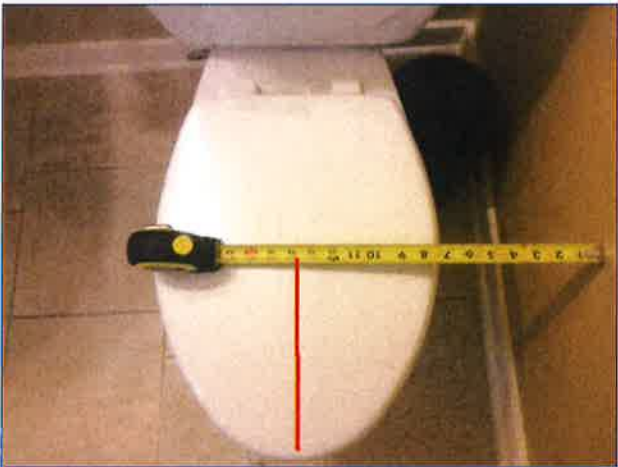
1. The commode in the powder room should have a minimum of 15" from the wall to the center of the commode. Currently there is only 13-3/4". Recommend possibly installing an offset flange to achieve proper clearance as a repair. Recommend consulting with a licensed plumber for further assessment.
2. The commode and tank in the powder room is currently installed crooked and not straight with the wall. In correspondence with item #1 in this section it is recommended to consult with a licensed plumber for repair.

A. Item 2(Picture) The commode in powder bath should be minimum 15" center from the wall.

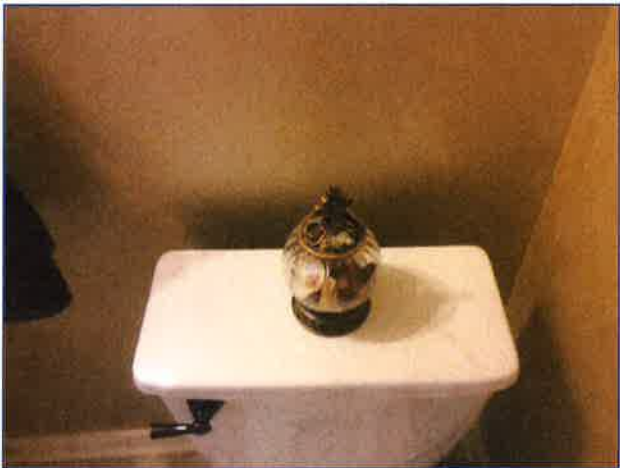
A. Item 3(Picture) Powder room commode is crooked and not straight.

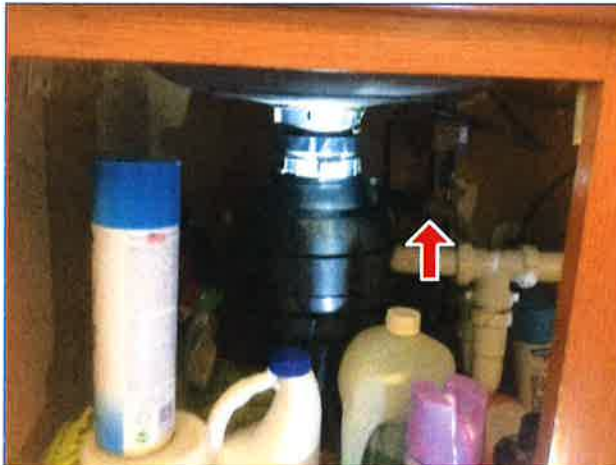
1. The dishwasher drain line lacks a proper air gap. Recommend creating a loop and tying the drain line at the highest point under the cabinet to achieve a natural air gap since one is not installed.

A. Item 2(Picture) Dishwasher is missing the air gap. Drain hose must be secured to the highest point to create an air gap if one isn't present.

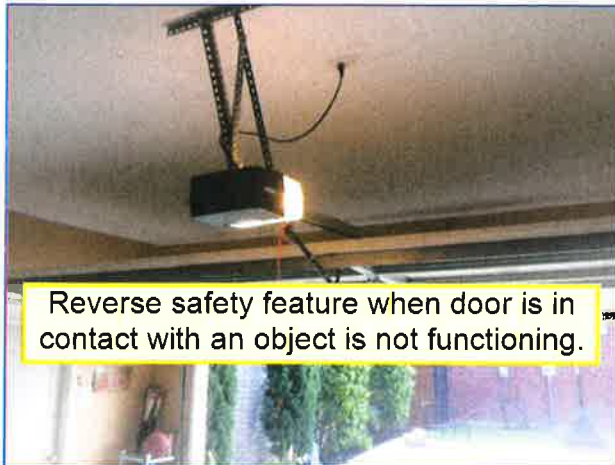
1. The reverse safety feature when the garage door comes in contact with an object does not function. Recommend adjustment of the sensitivity setting on the main unit for repair.

G. Item 1(Picture) The reverse safety feature when the door comes in contact with an object does not function recommend sensitivity adjustment at main unit.
